NORWICH RESERVOIR NO. 2 DAM

CHENANGO COUNTY, NEW YORK INVENTORY No. NY 349

PHASE I INSPECTION REPORT NATIONAL DAM SAFETY PROGRAM

NEW YORK DISTRICT, CORPS OF ENGINEERS MAY 1981

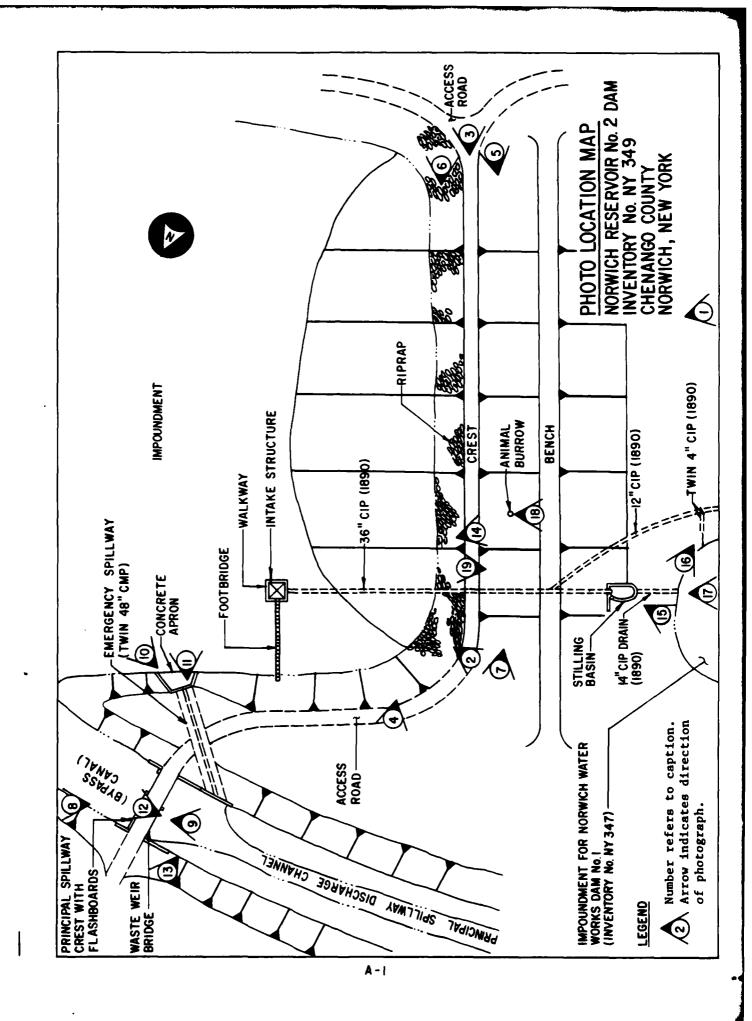
PHOTO #2: Overview of impoundment

The reservoir area is bordered by moderately to steeply sloping wooded land. There does not appear to be any significant probability of landslides into the storage pool affecting the safety of the dam (See Photo No. 2).
